## CASE STUDY

# LANGDALE AIR VALVE SERVICE

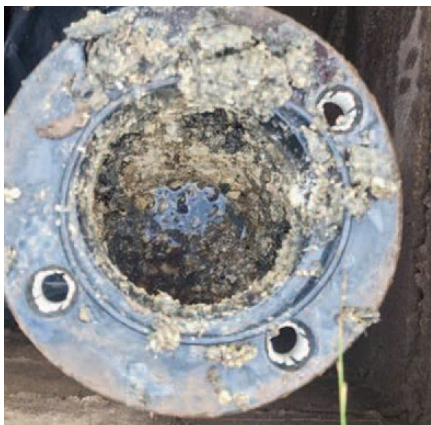
Build up of grease, making the air valve inoperable

Upon inspection, Glenfield Invicta's service team discovered each air valve was heavily impacted by a mass build-up of grease, moss, and leaves. This accumulation had rendered the valves inoperable, and the floats within each unit were entirely blocked by moss and other debris.

The Glenfield Invicta team began by dismantling each of the air valves, providing a full clean of all components to remove the layers of grease, moss, and other obstructions. This comprehensive cleaning allowed the valves to be restored to their original condition and ensured that all functionality was brought back to a high standard.

Following the cleaning, the team replaced the old, worn seals and fitted each valve with new floats to prevent future issues with blockages. Once the components were reassembled, the valves were recommissioned, ensuring that they would function smoothly and reliably for many years to come.

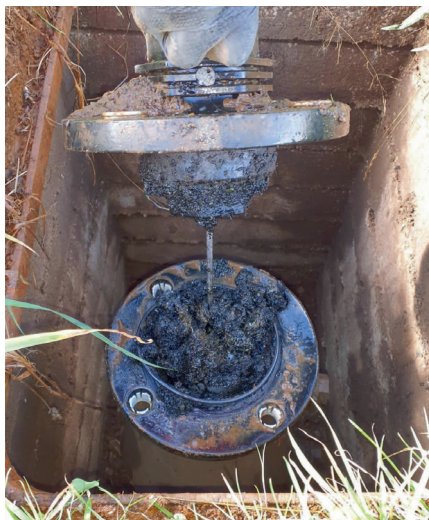
Contents of the air valve

These blockages prevented the air valves from functioning effectively, compromising their ability to release air pressure safely and potentially polluting the water.

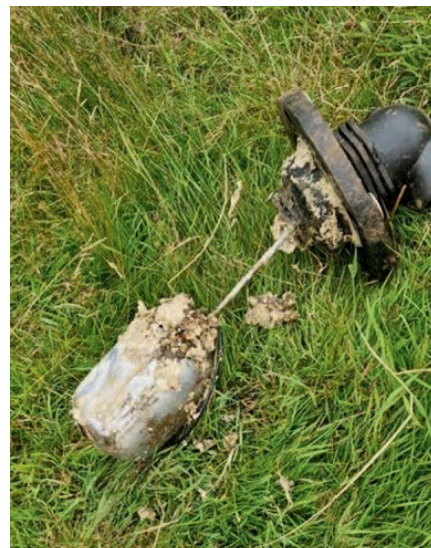
Internal float of the air valve with build up

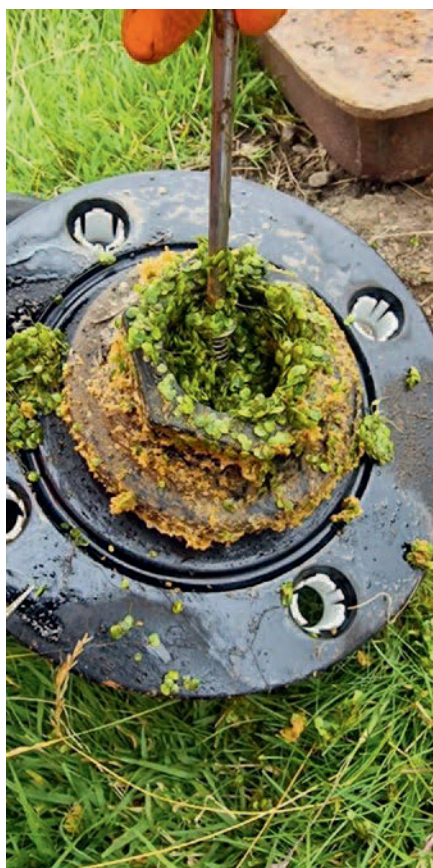
Seating mechanism packed with grease

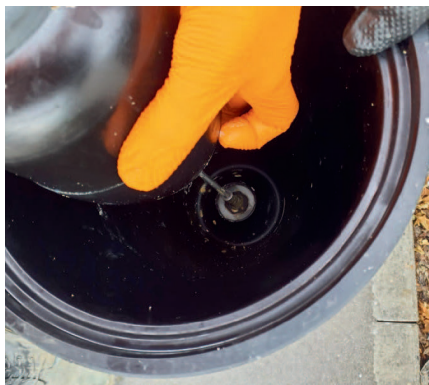
Cleaned internal of one air valve

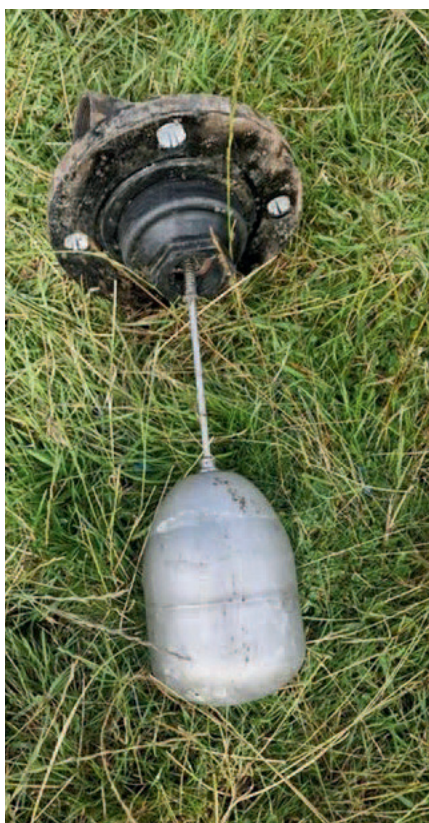
Air valve float after service

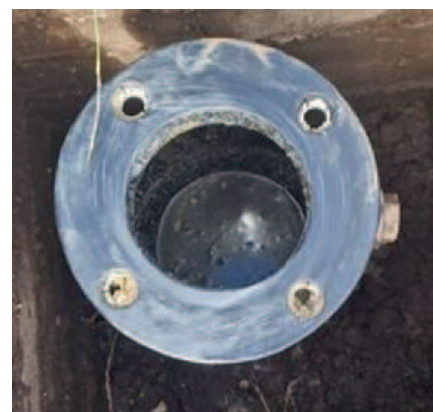
Air valve Internal after service
