## Langdale Air Valve Service

# Case Study Site Services

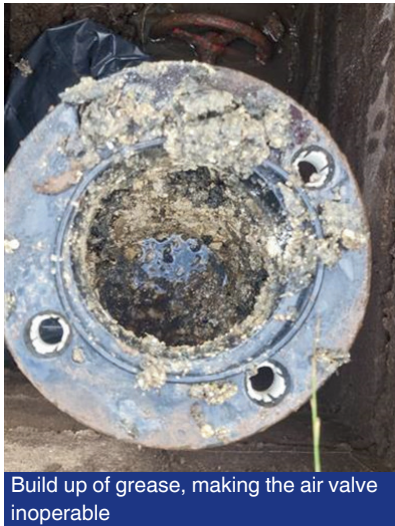
Build up of grease, making the air valve inoperable

Upon inspection, Glenfield Invicta's service team discovered each air valve was heavily impacted by a mass build-up of grease, moss, and leaves. This accumulation had rendered the valves inoperable, and the floats within each unit were entirely blocked by moss and other debris.

The Glenfield Invicta team began by dismantling each of the air valves, providing a full clean of all components to remove the layers of grease, moss, and other obstructions. This comprehensive cleaning allowed the valves to be restored to their original condition and ensured that all functionality was brought back to a high standard.

Following the cleaning, the team replaced the old, worn seals and fitted each valve with new floats to prevent future issues with blockages. Once the components were reassembled, the valves were recommissioned, ensuring that they would function smoothly and reliably for many years to come.

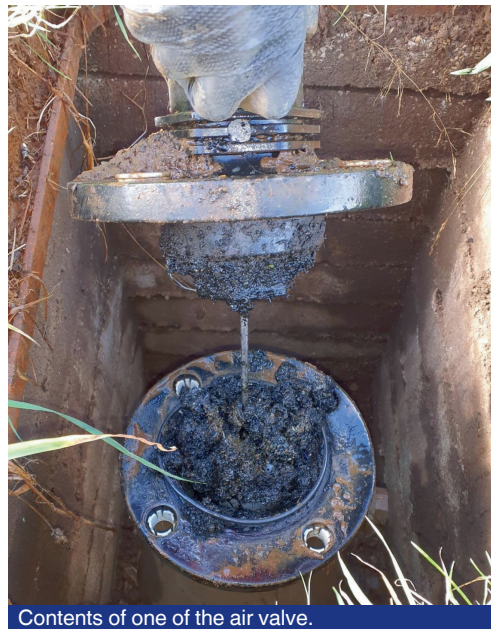
Contents of one of the air valve.

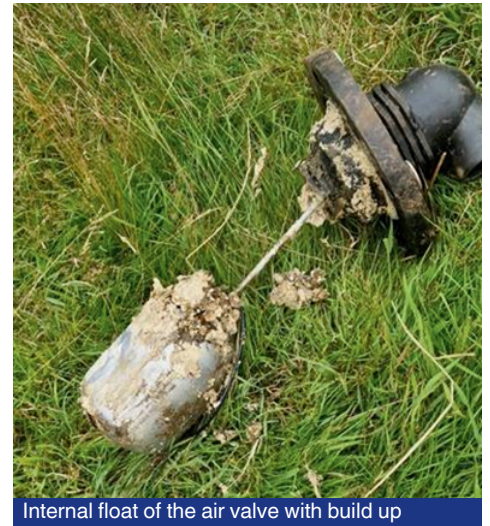
Internal float of the air valve with build up

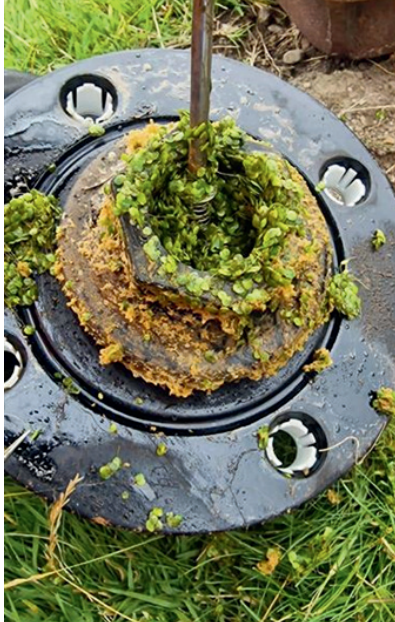
Seating mechanism packed with grease

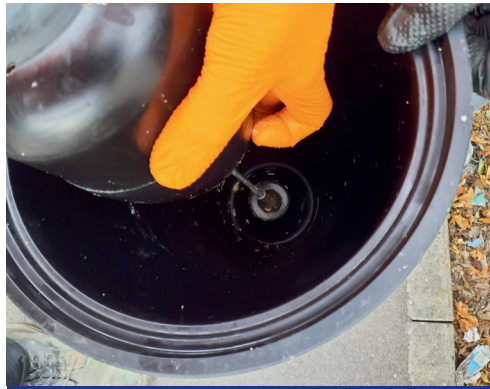
Cleaned internal of one air valve

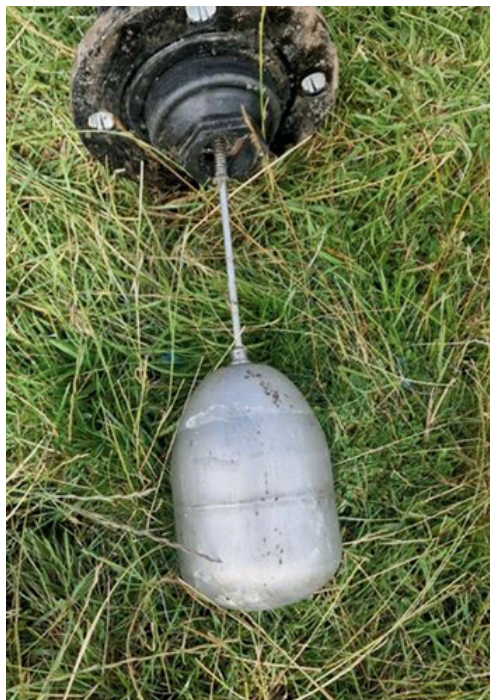
Air Valve float after service

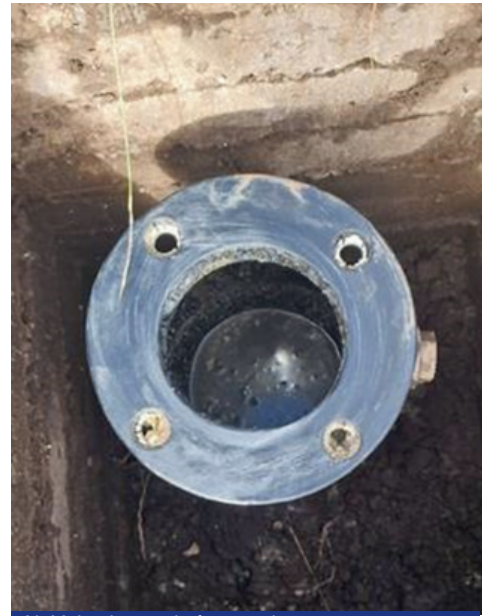
Air Valve internal after service
