Parkhead DSR

Float Valve Refurbishment and Reinstall

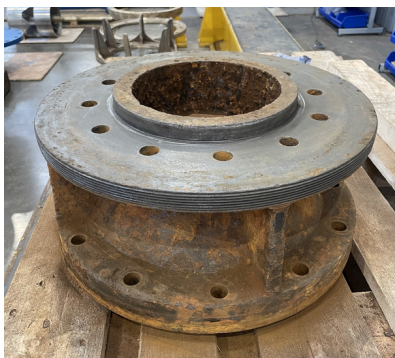
The Core Casting was in Reasonable Condition

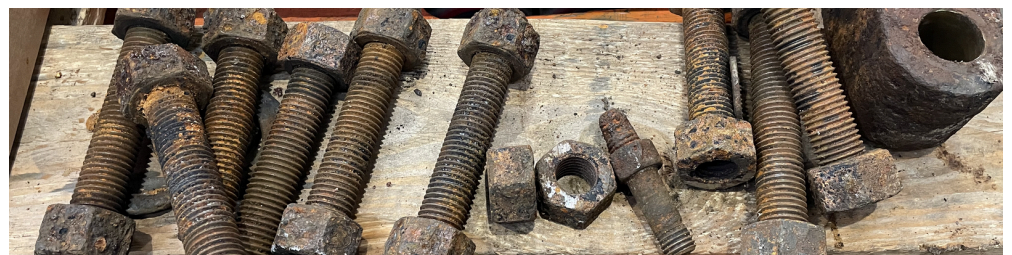
The Cover Fasteners were Badly Corroded

The Parkhead float valve was stripped down to its individual components by Glenfield Invicta engineers in its Kilmarnock workshops. The components were cleaned and then subjected to a detailed visual inspection. The inspection determined that the core valve casting was in reasonable condition, as were the bronze fastenings located within the valve. However, the bronze centre shaft was found to be bent. The valve's lever arm was badly corroded with a slight bend. Both the gaskets and seals were worn and damaged, contributing to the poor in-situ performance of the valve.

A replacement bronze valve shaft was reverse engineered, as were the seals and the gaskets. Due to heavy corrosion, the legacy valve cover fasteners were replaced with new.

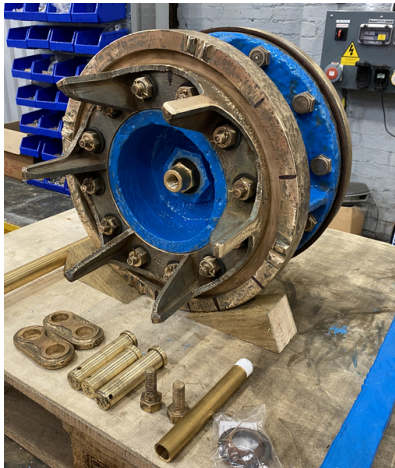
The Refurbished Valve & Fastenings

The valve centre casting was shotblasted and coated with a WRAS Approved paint. The slight bend in the lever arm was determined to have no impact on valve performance and this was also shotblasted and coated.

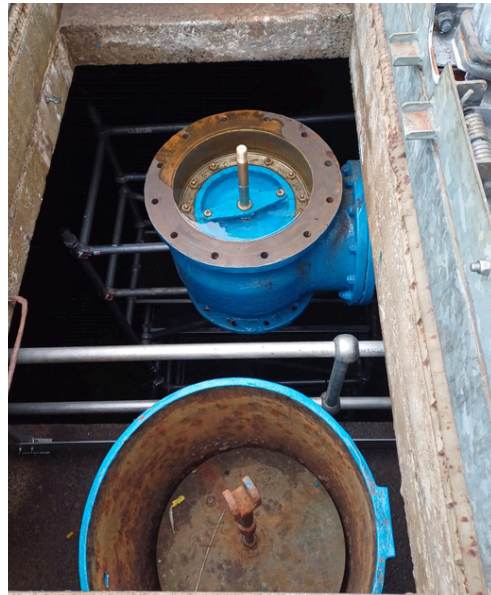
The Refurbished Valve before the installation of the cover and the lever arm

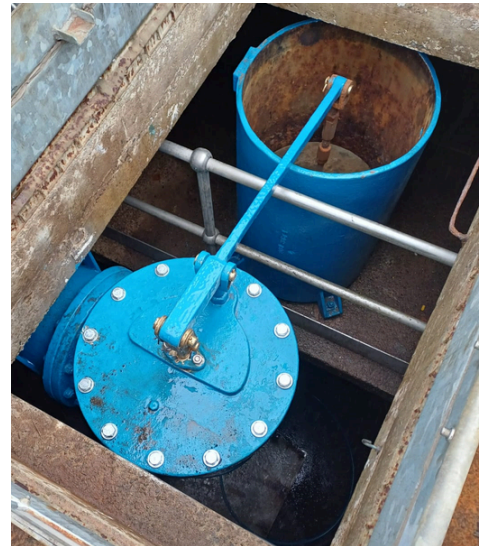
The Refurbished Valve Reinstalled Within the Service Reservoir

Glenfield Invicta engineers returned to the Parkhead DSR to reinstall the internal workings of the valve, and to undertake tests to ensure it was functioning correctly.
