## **Case Study** Hydropower

Glenfield Invicta were awarded a contract by Dales Engineering Services Ltd for client Scottish and Southern Energy (SSE) to refurbish two Needle Discharge Valves - one 48" and one 12" on the Sloy Hydroelectric Power Station.

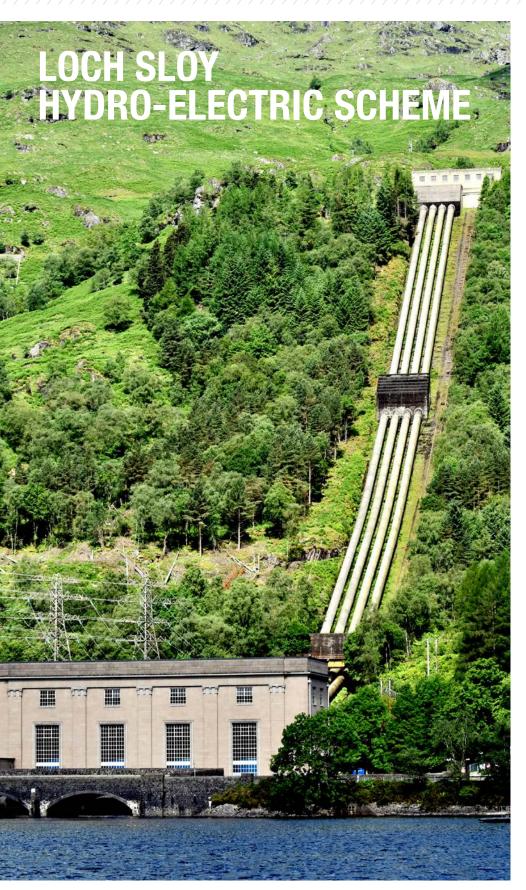
The Loch Sloy Dam, built as part of the Sloy Hydroelectric Power Station project. The Dam is 56m high and 357m long and raised the surface level of the loch by approximately 47m. The resulting Sloy Reservoir has a 17km<sup>2</sup> direct catchment area, although various pipes and intakes have provided a further 63km<sup>2</sup> of the indirect catchment area. The total volume of water held in the reservoir by the dam is approaching 36 million m<sup>3</sup>, and a 3km long tunnel takes water from Loch Sloy to a valve house positioned approximately 197m above the tank. From the valve house, four DN2000 steel pipes carry the water down into the powerhouse that is situated on the west coast of Loch Lomond. (See picture on left)
